**THE CORPORATION OF  
THE TOWNSHIP OF ST. JOSEPH  
COUNCIL MEETING  
MINUTES**

**RE: Richards Landing Children's Library – Foundation Structural Investigation (RFP 20-02)**

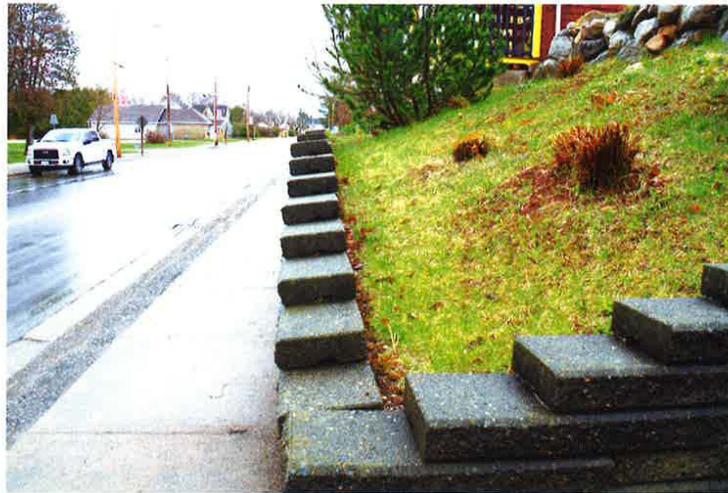
Photo 4: Interlocking block retaining wall.

The interlocking block retaining wall along the street side of the property is showing signs of failure; it is leaning towards the sidewalk. However, the concrete retaining walls surrounding the stairs and the stairs themselves appear sound.

The interlocking block retaining wall along the sidewalk is failing and requires remediation.

2. Reconstruct the interlocking block retaining wall. The wall is failing and needs to be reconstructed by an experienced contractor. The reconstruction should include complete excavation and dismantling of the existing wall, and reconstruction in accordance with manufacturer's recommendations or an engineer's design. Recommended budget for the above is [REDACTED]. When the wall is dismantled, the owner should consider installation of

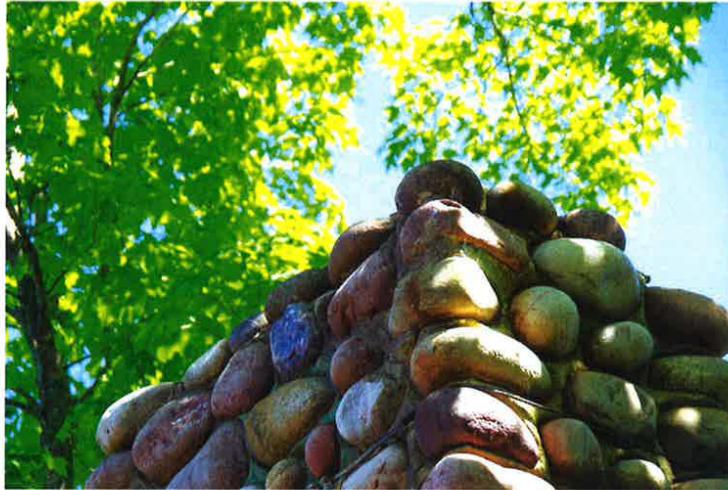
Photo 9: Top of stone chimney. Note lack of rain cap and steel cable wrap.

There are visible cracks in the mortar as well as areas where the stones and mortar have separated near the base of the chimney, indicating some movement following construction. Previous mortar repairs are evident near the base and historical repairs are apparent above the roof line. Above the roof, two steel cables are wrapped around the chimney and the mortar has been repaired. (Photo 9)

The cause of the separation between the building and the chimney is not definitively apparent and may be a combination of factors including: settlement of the chimney foundation, deflection of the building framing and deflection of the chimney itself. The separation has compromised the building envelope and provides opportunities for water ingress, heat loss, un-controlled air movement, etc. The envelope failure may lead to more severe deterioration of the structure, as well as possibly contribute to mold growth.

The gap between the stone chimney and the building has compromised the building envelope, and the chimney is in a deteriorated state. Previous repairs to the chimney have likely extended its life to present; however further rehabilitation is required.

1. Remove or rehabilitate the stone chimney. The chimney is not needed for any functional purpose and can possibly be removed and terminated with a waterproof closure at the top of its foundation. If the chimney is retained for esthetic/appearance purposes it is recommended to retain an experienced stone mason to re-point mortar joints where necessary, properly abandon the flues and affix a permanent waterproof closure at the top. Recommended budget: [REDACTED]

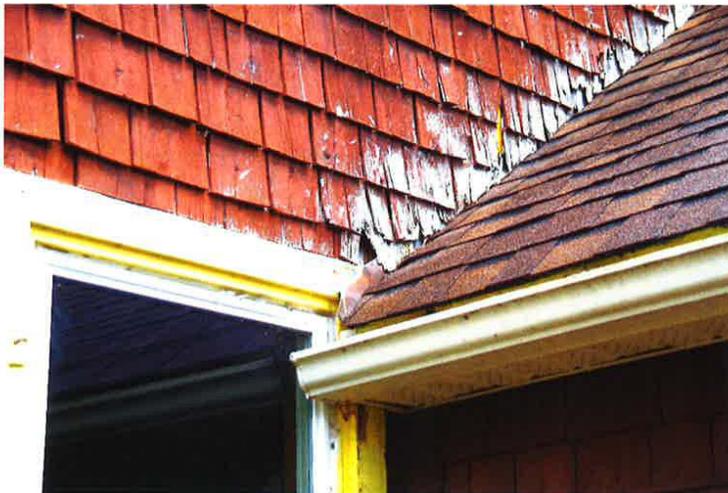
Photo 10: Roof wall interface at rear of south addition. Note siding deteriorated.

The building generally appears in need of maintenance; the siding is showing signs of rot in certain areas and requires new paint. Deterioration of the cedar shake siding is especially apparent along roof/wall interfaces, as well as near the base of the walls (Photos 10, 11). The siding also seems to have suffered damage possibly from woodpeckers.

Much of the cedar siding is in need of replacement.

4. Renew the siding. The cedar siding is in a deteriorated state and is no longer providing adequate protection to the building. It is recommended to remove the siding and install a new system, including building wrap, flashings, door and window capping, etc. The wide variety of available siding types precludes a definitive budget estimate; options can include new cedar shakes, vinyl, manufactured stone, some combination of these, or one of many other alternatives. Special attention should be taken to eliminate any openings which can allow pests to enter, including properly sealing the basement window and the former coal chute.

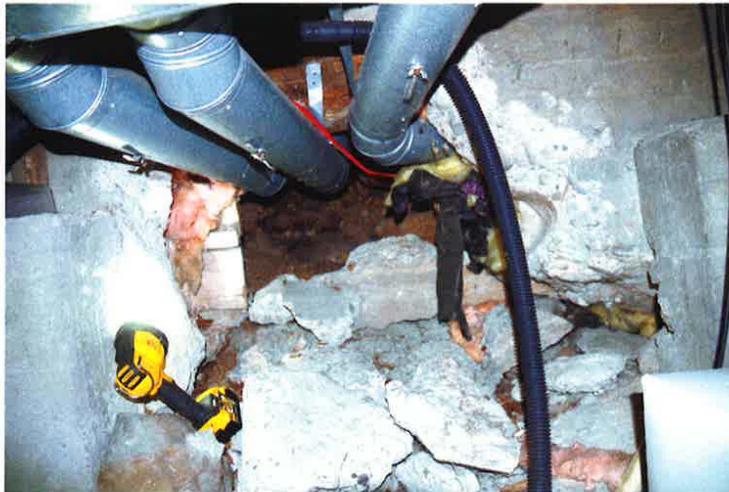
Photo 12: Opening from basement to crawlspace.

In the north end of the basement, a portion of the original foundation wall has been broken out to facilitate access beneath the main floor for heating ducts and electrical wiring (Photo 12). The opening was stuffed with fibreglass batt insulation at the time of the inspection; in order to view beneath the main floor, the batts were removed. The access point was not sufficient to allow entry into the crawl space for detailed viewing.
